SUBJECT: Prevent Inadvertent Rudder Trim Slipping During Extreme Deflections

**MODELS/ SN
AFFECTED:** M20M: 27-0343, 27-0351, 27-0352, 27-0355 & ON
M20R: 29-0412 & ON
M20TN: 31-0002 & ON
All Mooney M20U and M20V

**TIME OF
COMPLIANCE:** AT NEXT ANNUAL OR WITHIN NEXT 100 FLIGHT HOURS

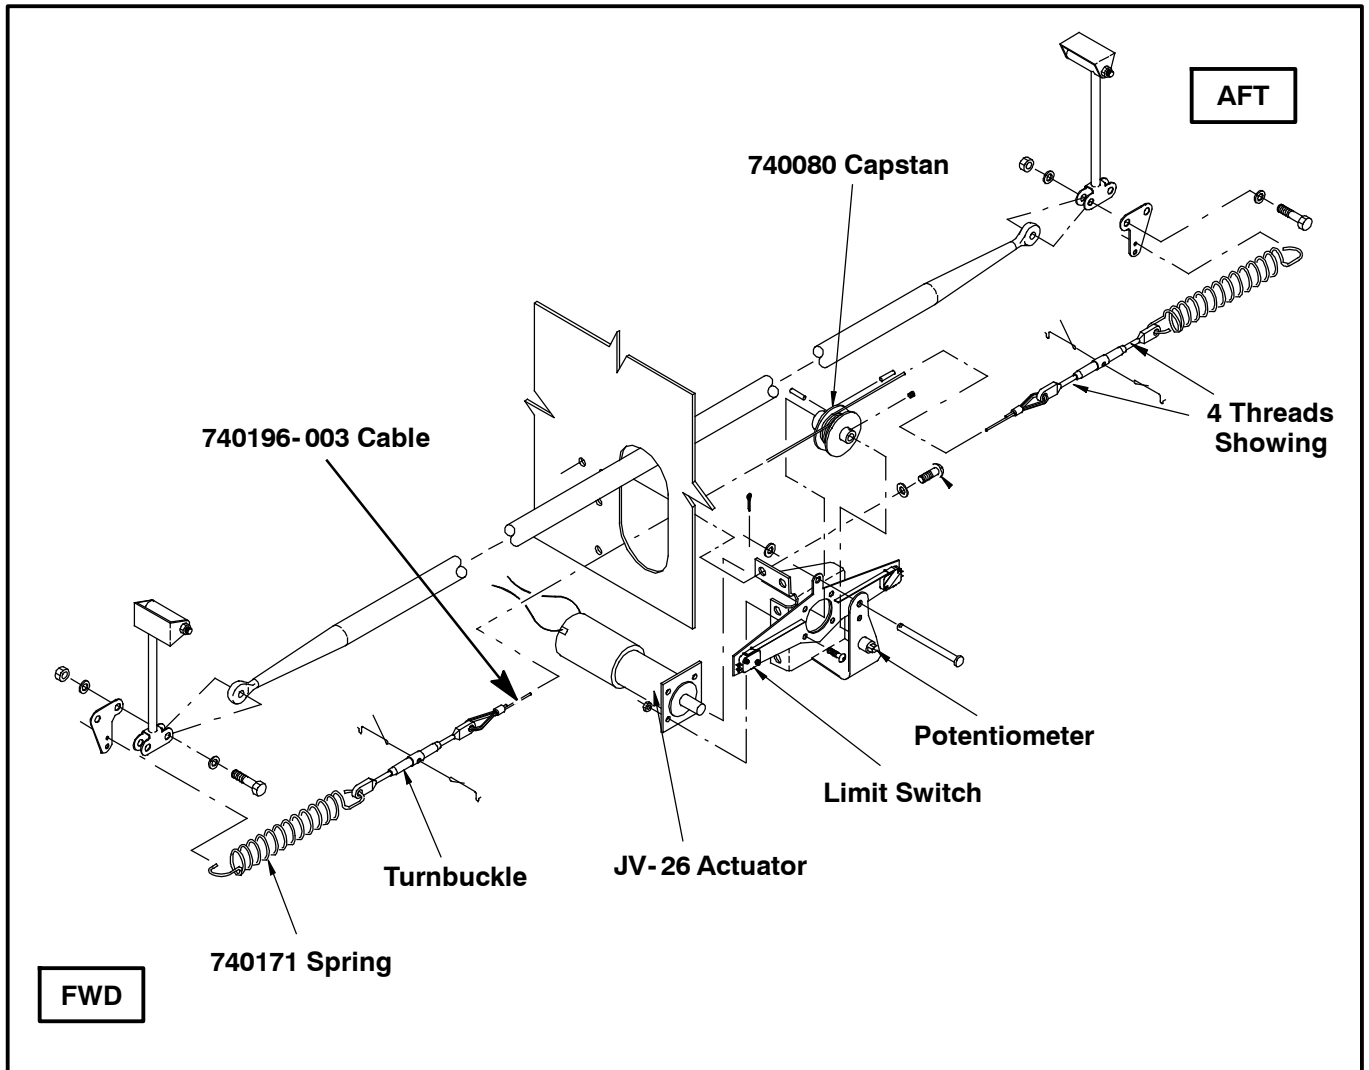
Figure SIM20-124-1 - Rudder Trim Rigging

INTRODUCTION: Mooney International Corporation has determined a solution to prevent inadvertent rudder trim slipping during extreme deflections during take off. Use of a new cable and a special GSE 030035 tool during installation are advised to prevent a permanent set in springs.

- 1.5. Wrap 740196-003 cable around 740080-001 capstan so that the forward eye of the 740196-003 cable is 10.75 inches from the forward surface of the 740080-001 capstan. Temporarily secure the cable using several wraps of a suitable tape around the cable and capstan. Install actuator assembly into the aircraft. Refer to Figure SIM20-124-1.
