MOONEY SPECIAL LETTER 15-17
Date: 9-21-2015

SERVICE BULLETIN

DATE: September 2, 2015 Service Bulletin No. 621A
(Supersedes all versions of Service Bulletin No. 621)
Engineering Aspects are
FAA Approved

SUBJECT: Diaphragm-Type Fuel Pump Replacement

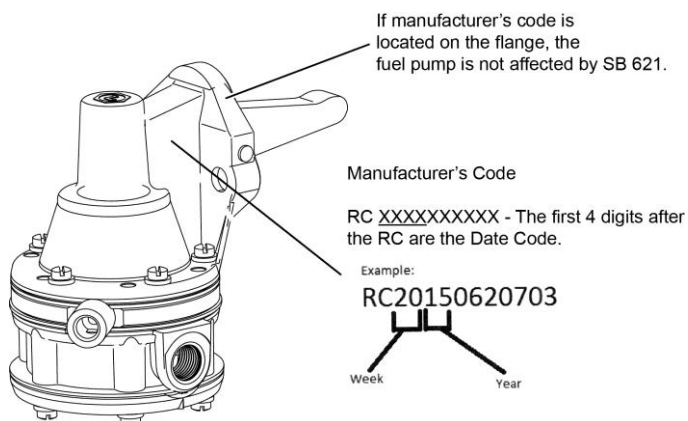
Figure 1
Manufacturer's Code Location on
Fuel Pump P/Ns 62B26931 and LW-16335

1. If the fuel pump is Lycoming part number 62B26931 or LW-16335.
2. If the manufacturer's code is not on the flange but is on the web or other parts of the fuel pump.
3. If the fuel pump has **RC** (Figure 1) as the first two letters of the manufacturer's code.
4. If the manufacturer's code identifies the fuel pump as manufactured before, up to, and including the 25th week of 2015.

If any fuel pump meets **all** the criteria above, remove the fuel pump from the engine or from the spares inventory and:

- A. Review your records to identify shipping dates of the serial numbers of any of the affected fuel pumps.
- B. Return all affected fuel pumps to Lycoming Engines with a copy of this Service Bulletin and file a warranty claim per the warranty procedure herein.
- C. Record removal of the fuel pump installed on the engine in the engine logbook.

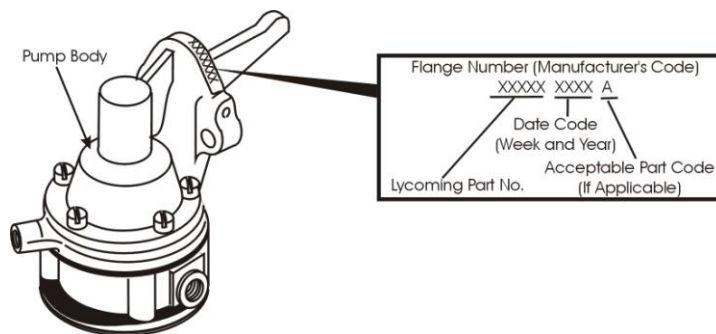
NOTICE: Each fuel pump has a 13-digit alphanumeric manufacturer’s code, which begins with two letters as shown in the example in Figure 1. The alphanumeric characters in the manufacturer’s code and its location on the fuel pump will help identify the fuel pumps affected by this Service Bulletin. The first two characters in the example manufacturer’s code RC20150620703 in Figure 1 are **RC**. The next two numbers **20** identify the manufacturing week of the year as **20** and **15** is the year. The manufacturer’s code is on the fuel pump flange or on the web as shown in Figure 1. If the manufacturer’s code is on the flange as in the example in Figure 2, the fuel pump is not affected by this Service Bulletin.

Figure 2
Manufacturer's Code on the Flange
(Fuel Pump Is NOT affected by SB-621)
